NPS-69PS-78-005

MORPHOLOGICAL EVIDENCE FOR A PITTING MECHANISM IN DILUTE ALUMINUM ALLOYS

J. Perkins, J. R. Cummings and K. J. Graham

June 1978

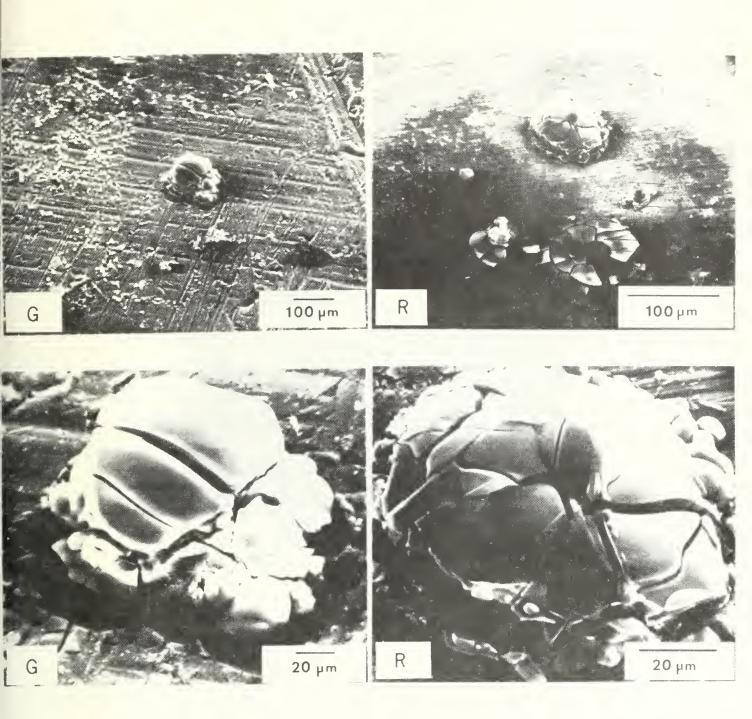
Figure 4: Less frequently observed are pitting and mound features on the unattacked regions of alloys G and R.
